Assessing the Resurgent Irrigation Development Program of the Philippines – Communal Irrigation Systems Component

Roger A. Luyun Jr. and Dulce D. Elazegui

PHILIPPINE INSTITUTE FOR DEVELOPMENT STUDIES

March 2020

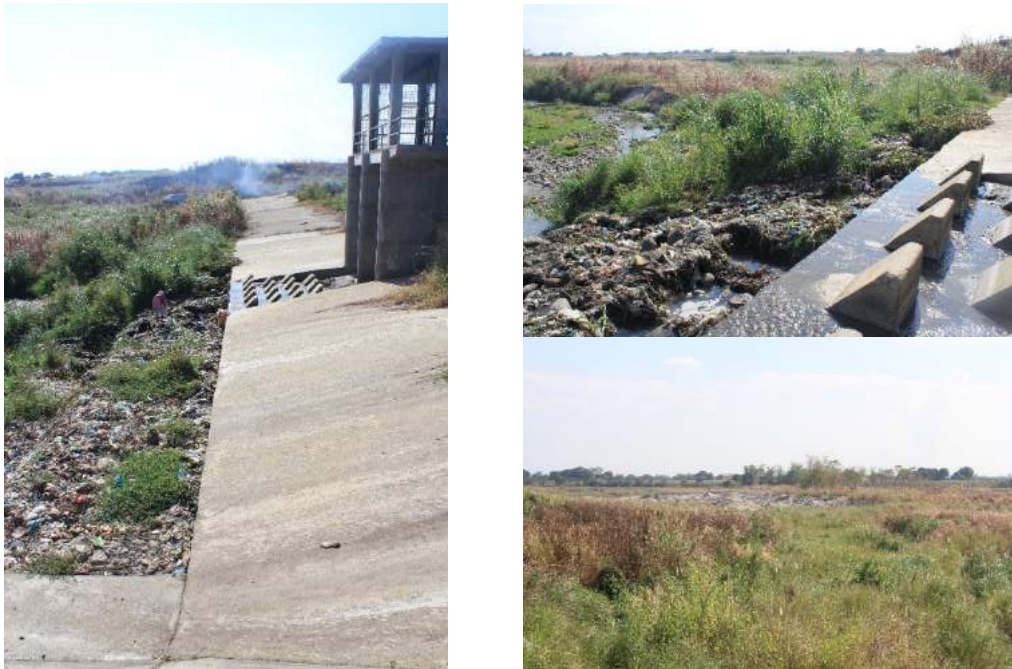
Figure 1A-16. Clockwise from left: (a) scouring at the downstream apron, the sluice gates and intake structures are seen at the middle of the dam; (b) the gabions are damaged and accumulating garbage; (c) the quarry operations just downstream of the dam location

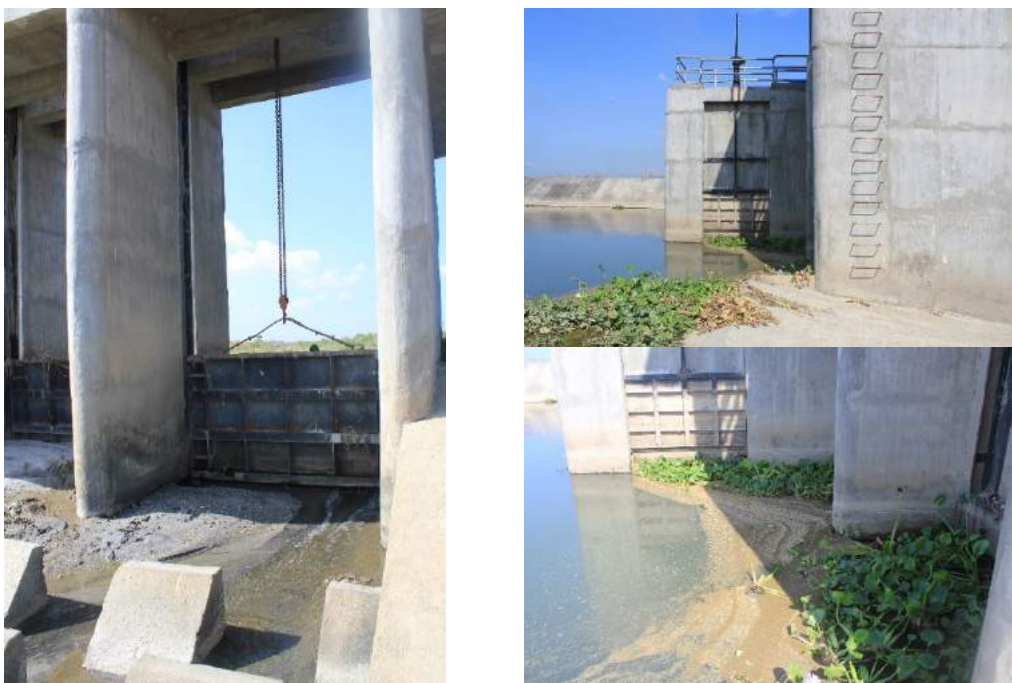
Figure 1A-17. Clockwise from left: (a) the two sluice gates showing some siltation and leakage, also shown are the baffle blocks; (b) The intake structure was designed to be near the middle of the river, the intake gates are still functional; (c) the approach to the sluice gates and intake gates are heavily silted

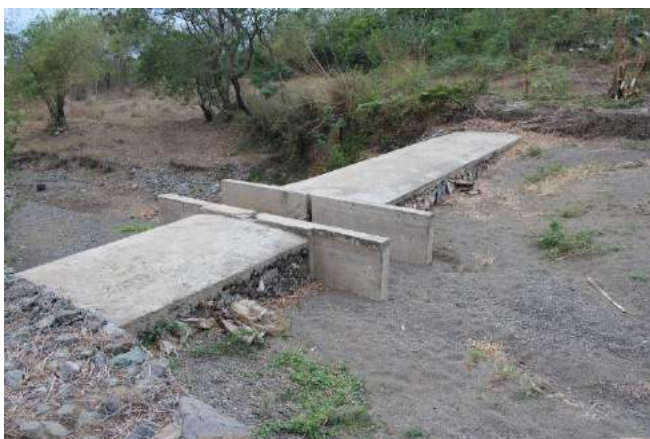
Figure 1A-23. There is no water in the creek during the time of visit and the sediments are almost up to the dam crest

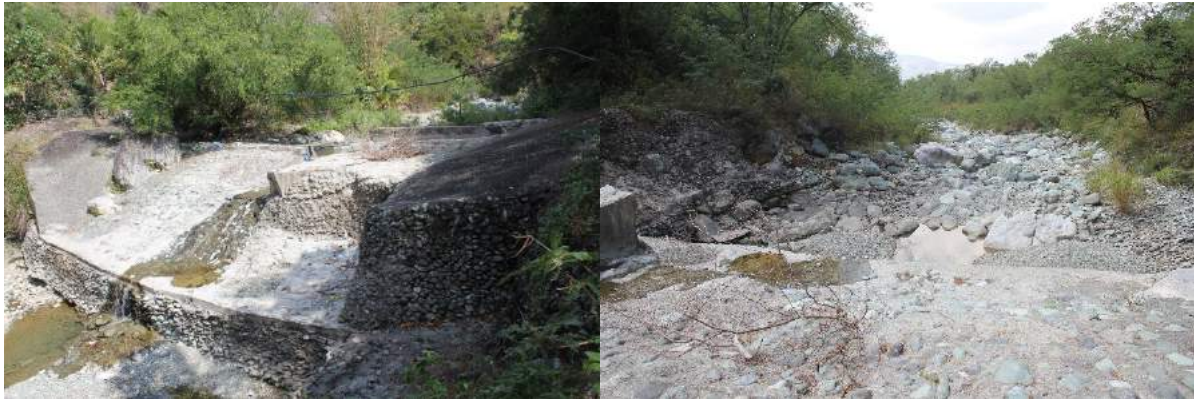
Figure 1A-28. Left: The Inasan CIS dam along the upstream of the Inasan River made of rock and concrete; Right: boulders and rocks downstream of the dam

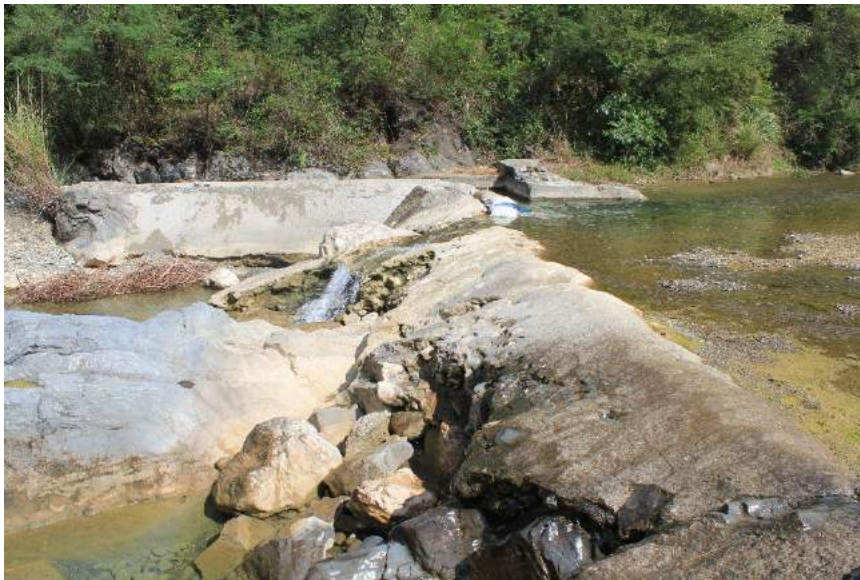
The dam is currently in under disrepair with damaged ogee spillway and downstream apron (Figure 1A-36). The core of rocks and boulders are already exposed and the sediments are almost at crest level. The sluice gate is now made up of piled rocks, woods and sand bags (Figure 1A-37). But enough water is still entering the intake structure (Figure 1A-38) at the time of the survey. The intake structure channels water through an intake channel that lines one side of the river, which then leads into the main canal (Figure 1A-39). Flow to the main canal is controlled by a check gate and the excess water is reverted back to the river through another check gate (Figure 1A-40). The main canal is fairly well maintained with minor siltation and at the time of the survey, the discharge was measured at (Figure 1A-41). Part of the water flowing on the main canal is diverted across the river through an inverted siphon (Figure 1A-42) to irrigate farms in that area. This siphon has been repaired and unclogged once before and still functional during the visit. The IA wants to have an additional siphon to prevent disruption of operation and also to line their unlined canal to increase efficiency of the system.

Figure 1A-36. The Parang-Bugnan CIS dam; the damage at the ogee spillway exposes the dam core made of rocks and boulders; the sediments are almost at the dam crest level

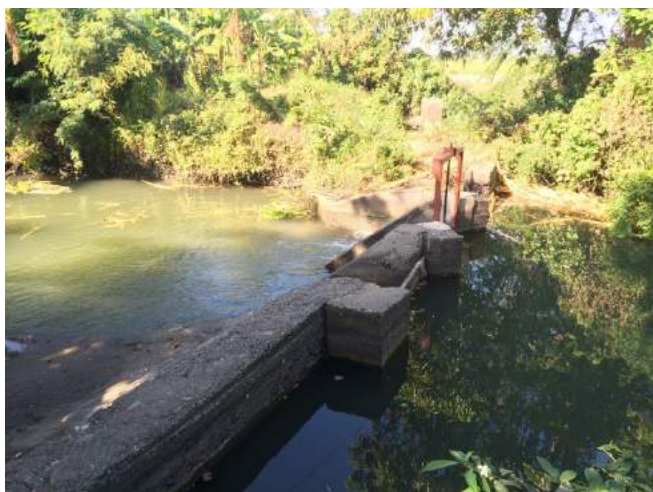
Figure 1A-60. A check gate with one steel gate damaged and replaced with wooden plank

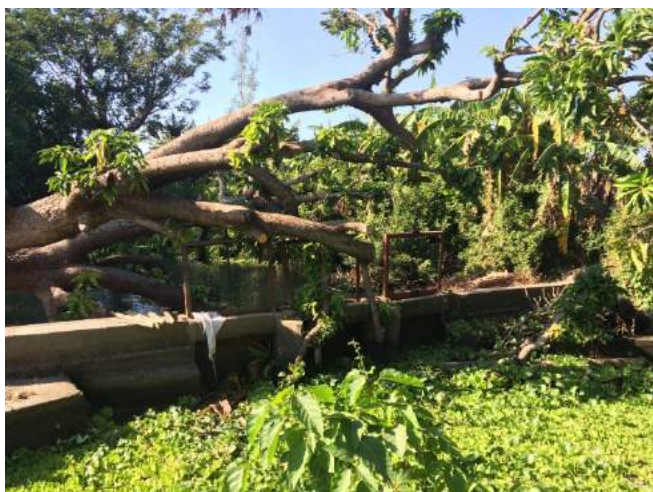
Figure 1A-61. Damaged and non-operational gates due to a tree falling on it during the typhoon Mario in 2014.

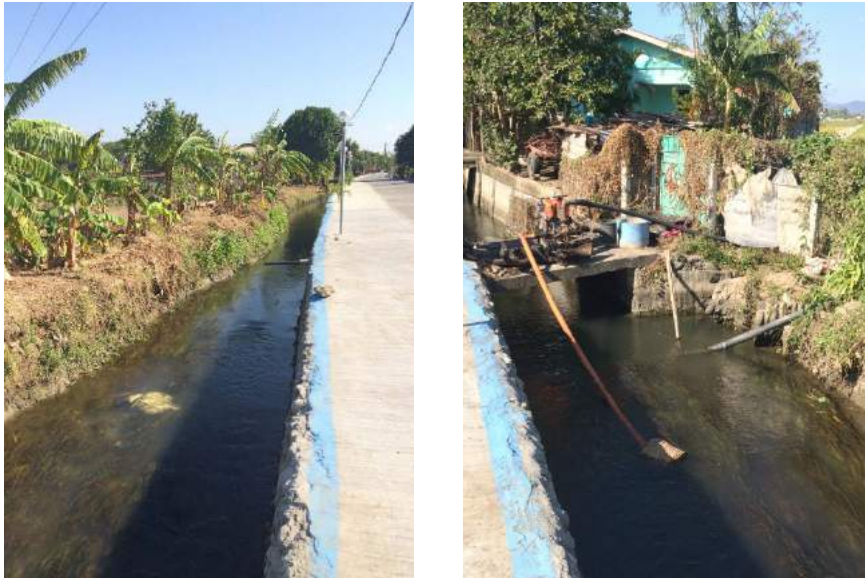
Figure 1A-62. Lateral canals: Left – grasses are growing at the channel bottom; Right – a low-lift pump (LLP) extracting water from the canal (according to the farmer interviewed, the owner of this pump is not a member of the IA).

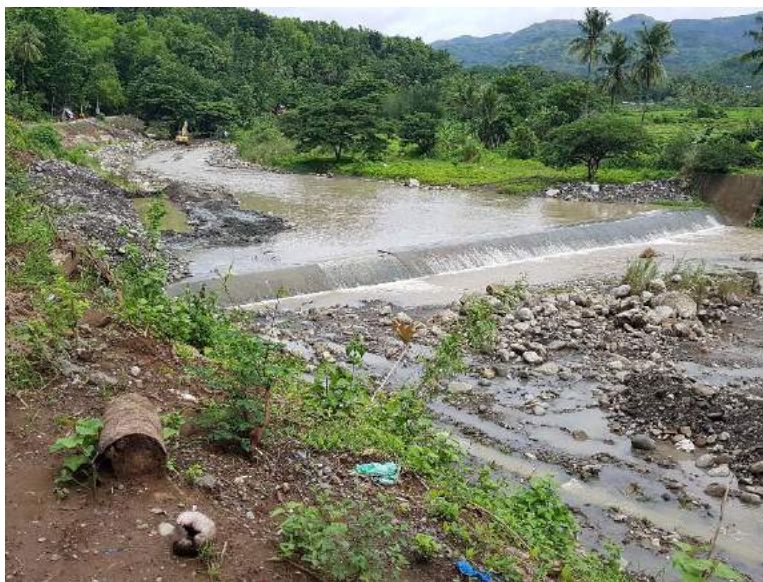
Figure 1B- 24. The Tumagboc CIS dam affected by a road construction on the left

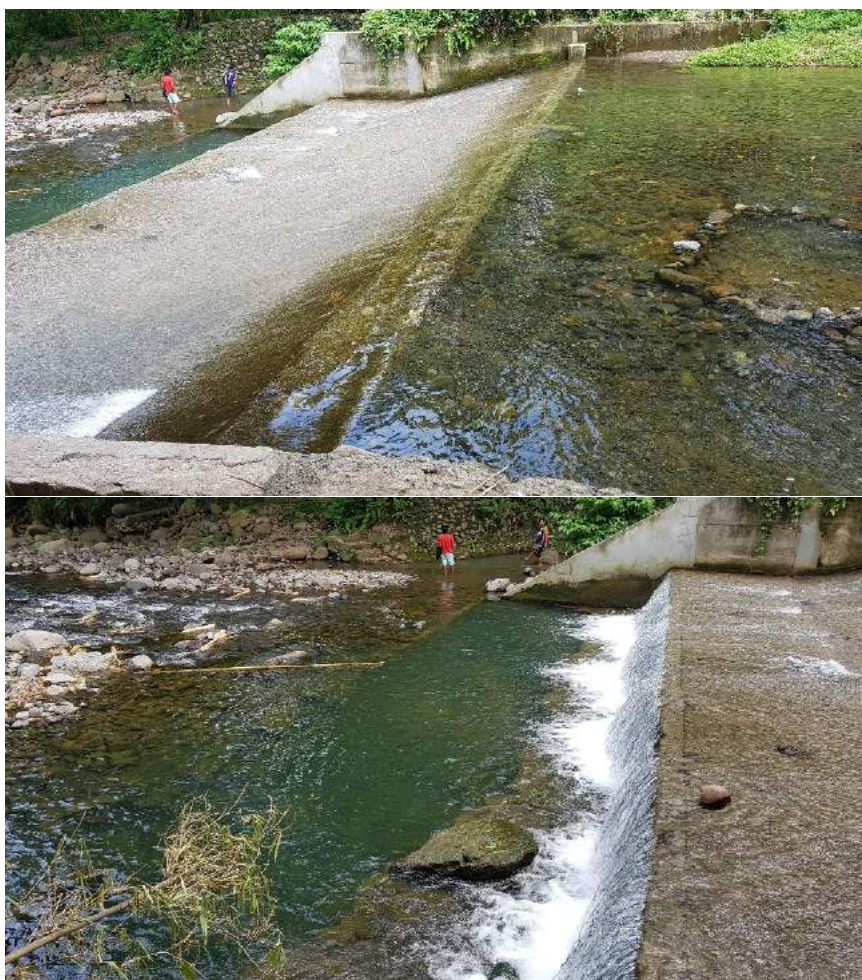
Figure 1C-1. Marapangi Dam of Unifarm CIS showing sedimentation and damaged downstream apron of the dam

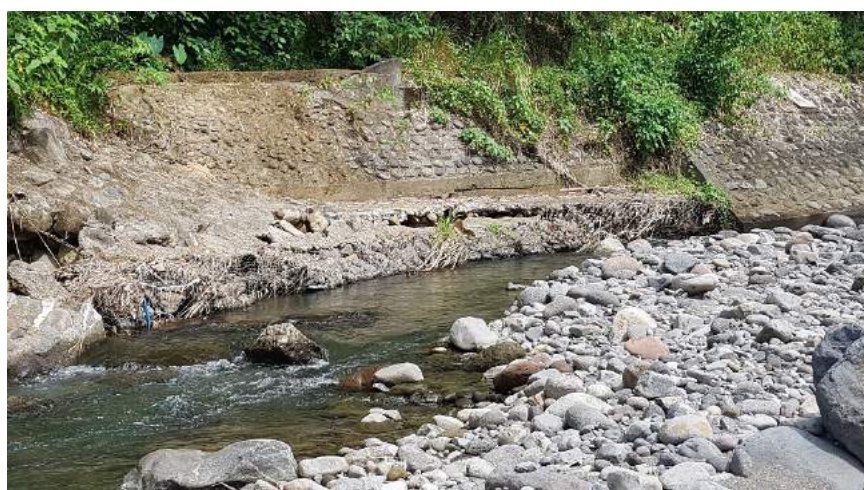
Figure 1C-4. Riprap of bench flume damaged by floods
