Assessing the Resurgent Irrigation Development Program of the Philippines – Communal Irrigation Systems Component

Roger A. Luyun Jr. and Dulce D. Elazegui

PHILIPPINE INSTITUTE FOR DEVELOPMENT STUDIES

March 2020

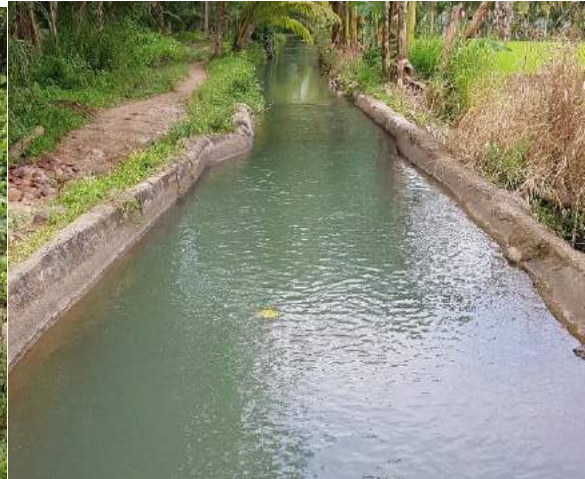
Figure 1C-12. Main canal of the system

The current dam (Figure 1C-10), including the steel sluice gates and intake gates (Figure 1C-), were constructed by NIA in the 1990's. There were problems of sediments and debris flow so the IA added a silt control structure (Figure 1C-11) costing the IA about ₱50,000. The same problem caused damaged to the sluice gate and the IA repaired it at a cost of a little less than ₱30,000. The dam structure and lining require some repair due to debris and boulder laden flow and the IA conduct regular dam cleaning and desilting. The single gated sluice gate was deemed insufficient and the direction of the training wall is causing more sediments to flow to the intake gates than be flushed through the sluice gates. Most of the main canal is lined although some parts, particularly near the dam, are submerged while some are damaged causing leakages (Figure 1C-12). Sands that accumulate in the main canals are collected and sold by farmers.
