Assessing the Resurgent Irrigation Development Program of the Philippines – Communal Irrigation Systems Component

Roger A. Luyun Jr. and Dulce D. Elazegui

PHILIPPINE INSTITUTE FOR DEVELOPMENT STUDIES

March 2020

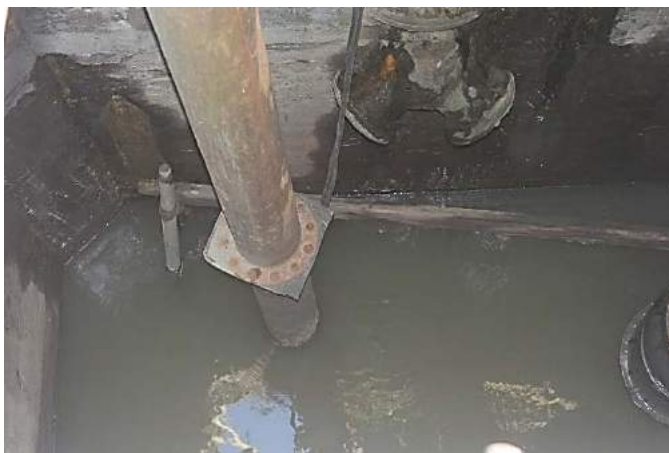
Figure 1A-3. The concrete intake pit for the suction pipes of the Gulap Pump Irrigation System; also shown is the 10-in pipe of the submersible pump

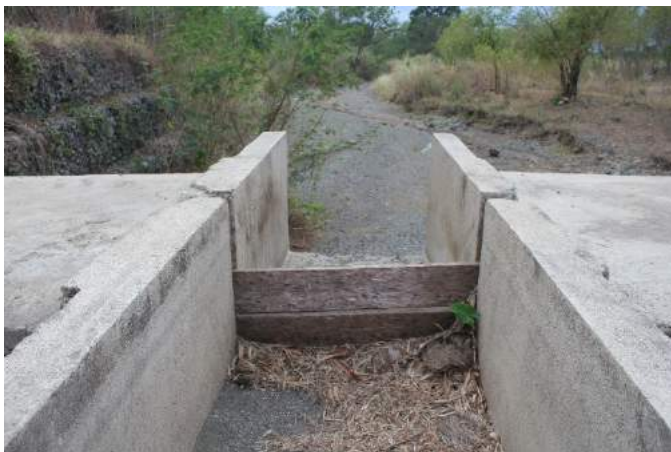
Figure 1A-25. The sluice gate is made of concrete with slots for wooden slabs serving as gates; the background is the downstream portion of the dam

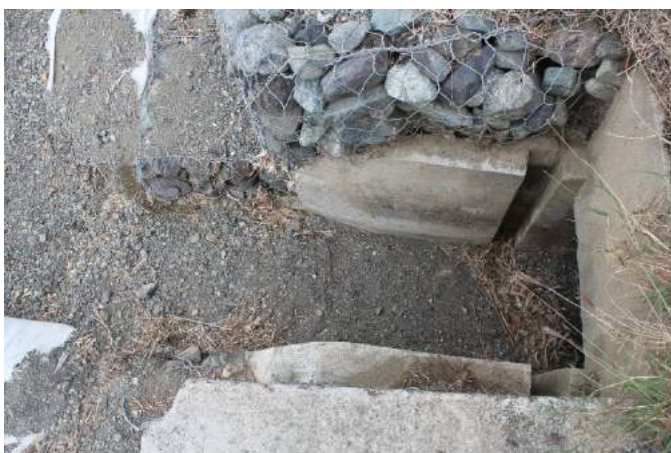
Figure 1A-26. The intake structure with the slots for the wooden gates

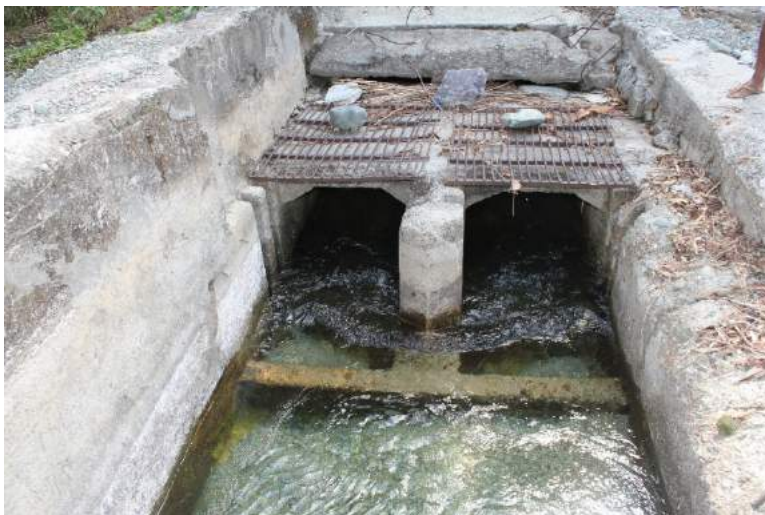
Figure 1A-30. The intake structure leading to the underground tunnel into the main canal

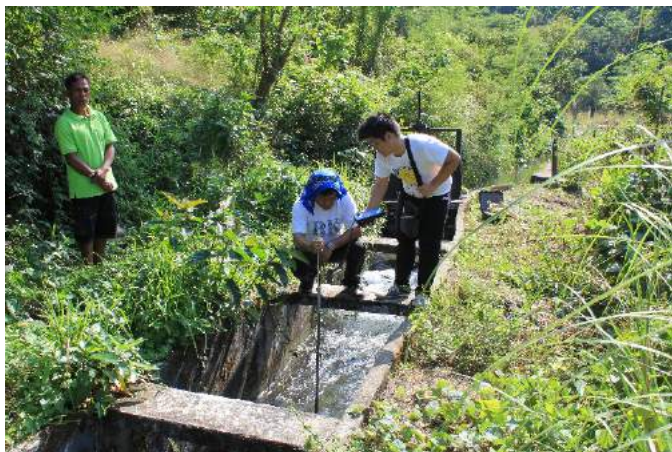
Figure 1A-41. Measuring discharge at the main canal during the walkthrough

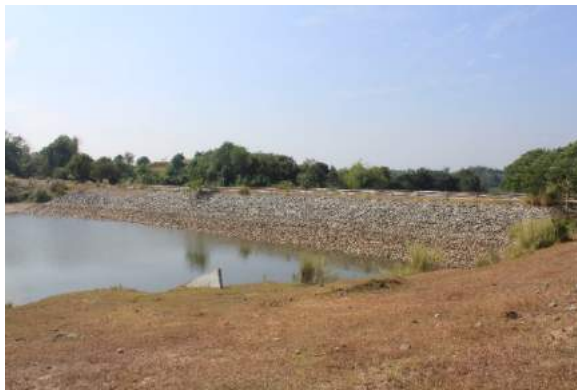
Figure 1A-43. The dam of the San Angel SRIP

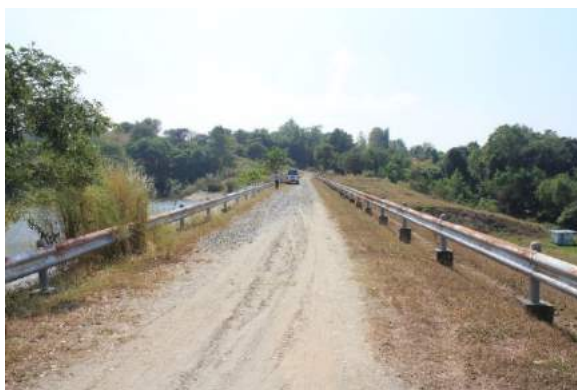
Figure 1A-44. The road atop the dam crest

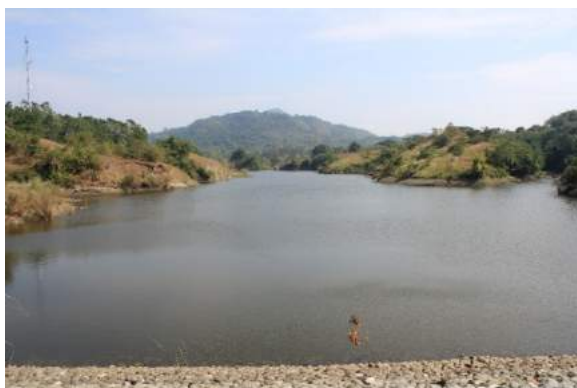
Figure 1A-45. The reservoir of the San Angel SRIP; also shown are the rocks lining the slopes of the upstream face of the dam

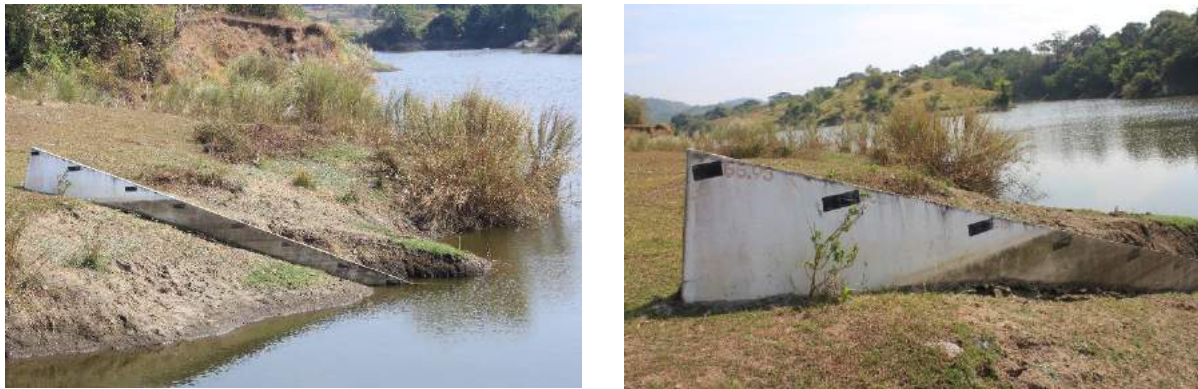
Figure 1A-46. The water level gage meter made of concrete reservoir of the San Angel SRIP; also shown are the rocks lining the slopes of the upstream face of the dam

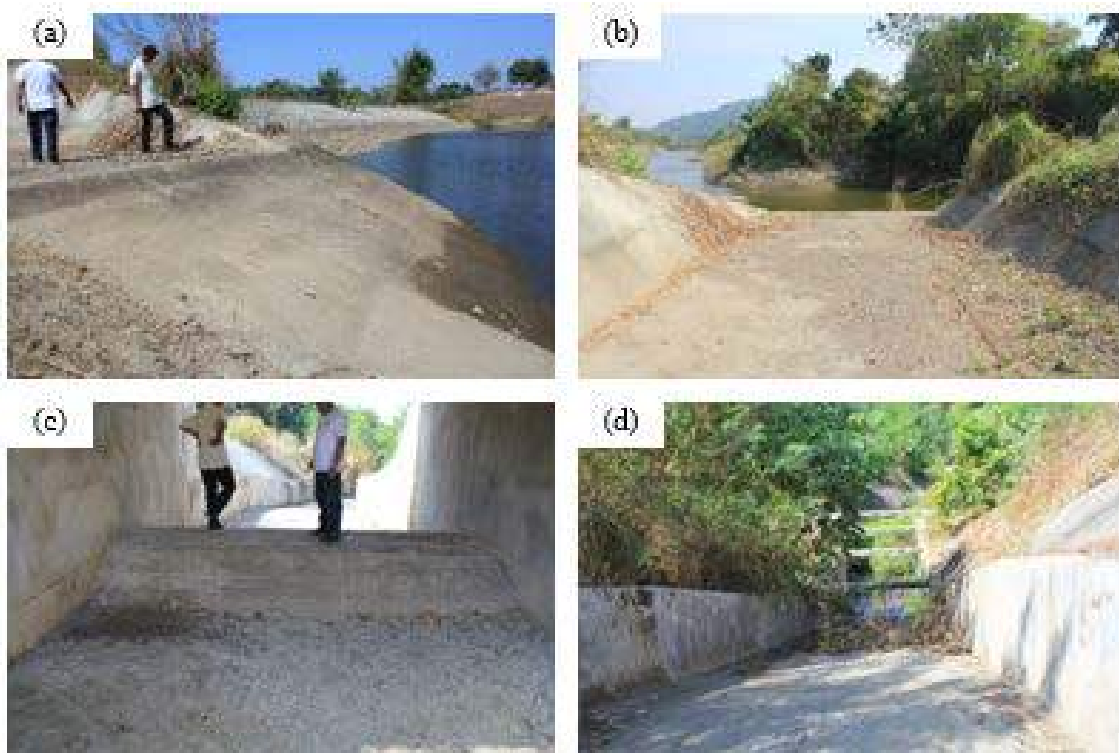
Figure 1A-47. (a) The entranceway to the concrete spillway; (b) the level spillway channel; (c) the hump along the spillway channel to increase storage capacity of the dam; (d) the spillway chute to channel excess water from the dam to a creek

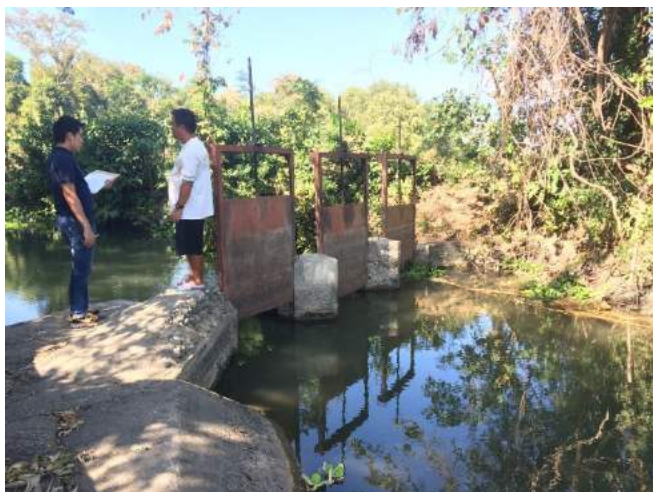
The IA was able to generate PhP 250,000 from LGUs last 2010 for riprapping. They also raised PhP 280,000 in 2013 to install/repair three sets of gates. Heavy siltation occurs on the first set of gates near the intake structure (Figure 1A-59). In the second set of gates (upstream), one of two check gates is broken and a wooden plank is used as replacement (Figure 1A-60). In the third set of gates (midstream), the three gates are damaged and non-operational because a tree fell on it last 2014 during typhoon Mario (Figure 1A-61). It has not been fixed yet though the IA has been requesting for repair since. Since the third set of gates were broken, the IA have experienced water shortage in the downstream portion of the system. There is no water master/tender so the officers just take turns in operating the gates. The IA uses both STW and LLP for other crops (tobacco, garlic, onion). But illegal pumping from the main and lateral canals occurs. Some farmers pumping water are not even members of the IA. Some lateral canals have unwanted grasses growing at the bottom and banks.

Figure 1A-59. The intake structure of the dam

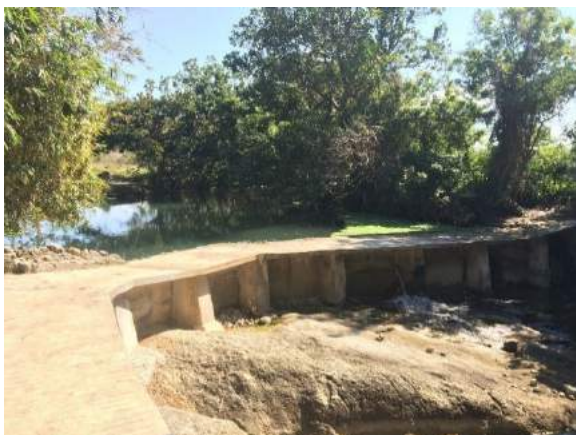
The dam is a simple concrete dike (Figure 1A-63). The intake gate is broken and only wooden planks are used (Figure 1A-64). The main canal have patches of concrete lining (Figure 1A-65). Holes were made in the main canal to serve as turnouts to lateral canals where rocks are used to control the flow of water. A part of the main canal is along the national highway where some rocks from the highway contribute to the canal's sediments. Heavy siltation also occurs in a road crossing especially during the wet season clogging it. The IA spends at least a day to clean the clogged culvert.

Figure 1A-63. The simple concrete dam of the Der-Ap Saoit CIS

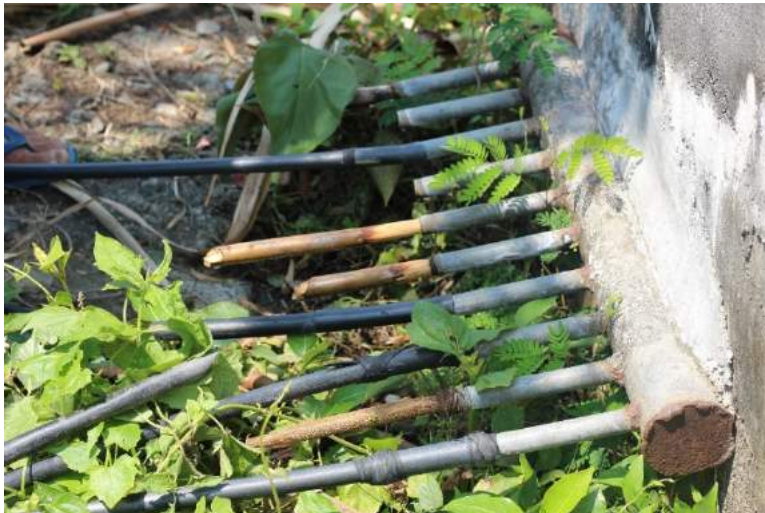
Parasipis CIS is located in Tuba, Benguet. It gets its water primarily from a spring but also taps water from a river during the dry season when the spring flow is low. The spring water was certified as Class A by the DENR. The river flow, on the other hand, gets murky during the rainy season. A small pool is created at the source where water enters a screened inlet and distributed using 119 rolls (60 m/roll) of 2-in dia. HDPs. From this main line, water is diverted to four concrete tanks (three 8x8x8 m and one 4x4x4 m). Each of these tanks (Figure 1A-81), has an overflow pipe for channeling excess water and an opening at the top where a man can enter for tank cleaning. Water is distributed to each farms from a distribution assembly (Figure 1A-82) at the tank and using individual HDPs. They have no gate valves in each distribution pipe so they use wood stems to plug each pipe when not in use.

Figure 1A-82. The distribution pipe assembly showing wooden plugs

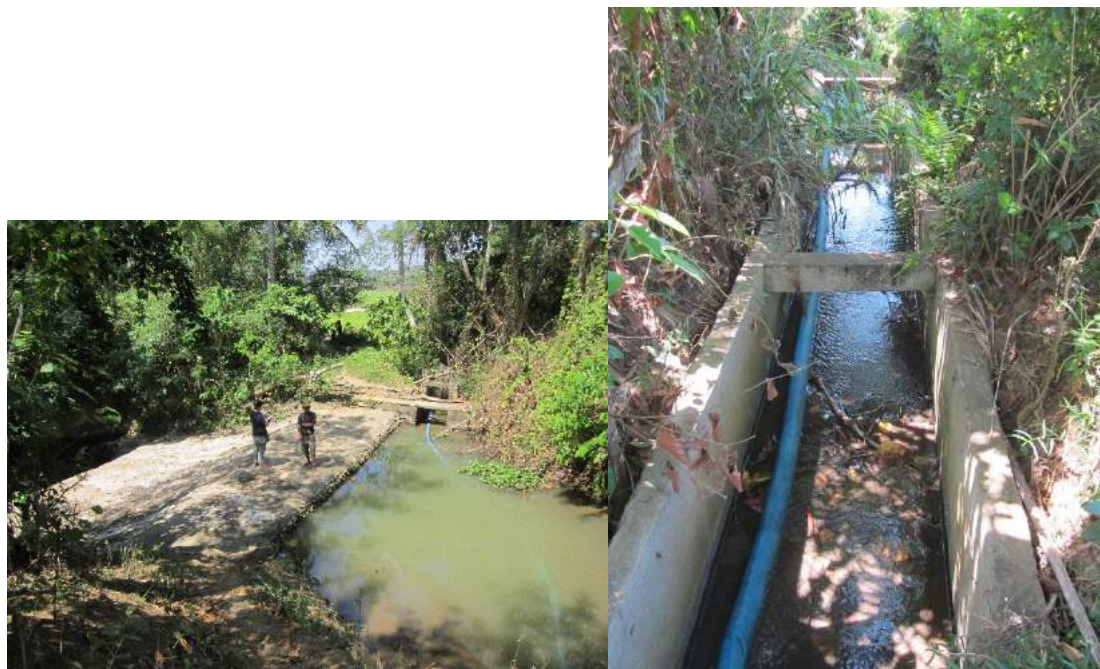
Figure 1A-101. The brush dam now made of concrete and the rectangular lined canal constructed by the IA; water is pumped to the canal due to low flow

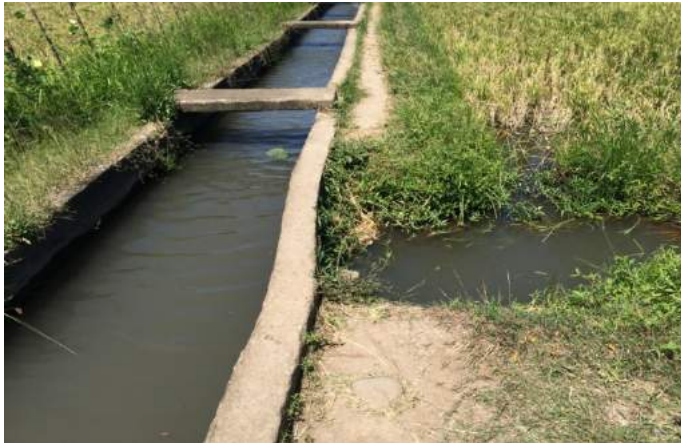
Figure 1A-102. The intake of the Maria Pelaez Communal Irrigation System

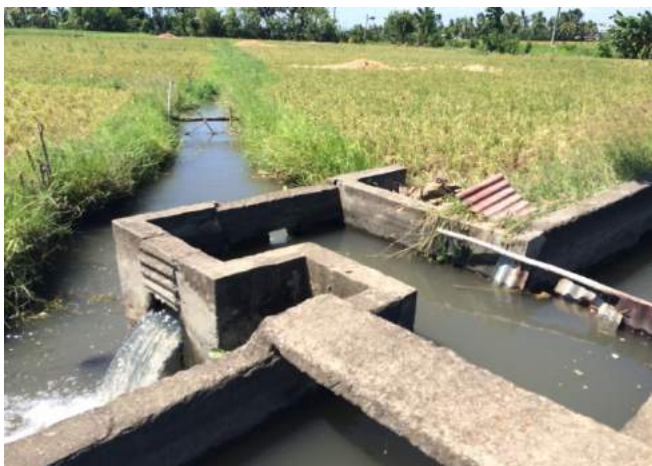
Figure 1A-103. The 1-m wide, 1-m deep concrete-lined main canal of Maria Pelaez CIS
Source: Author's capture

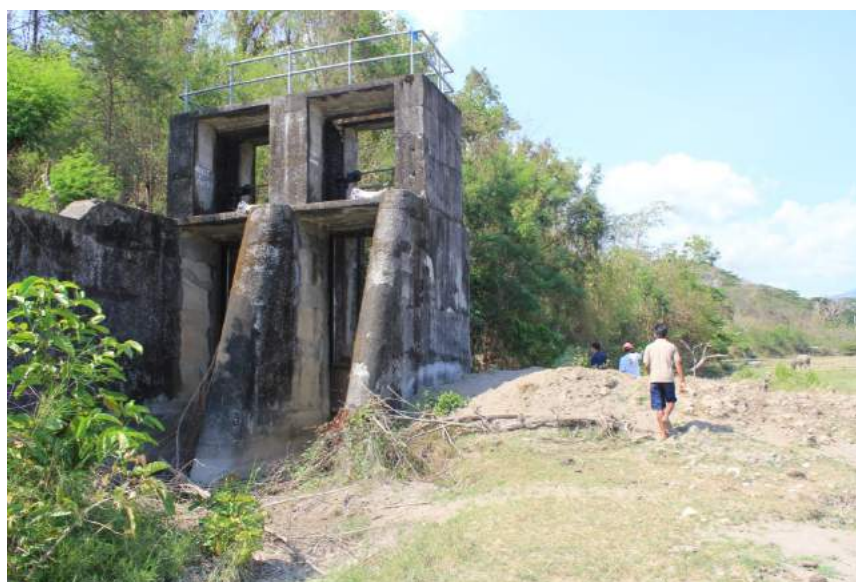
Figure 1A-111. The Bongbongan CIS Dam

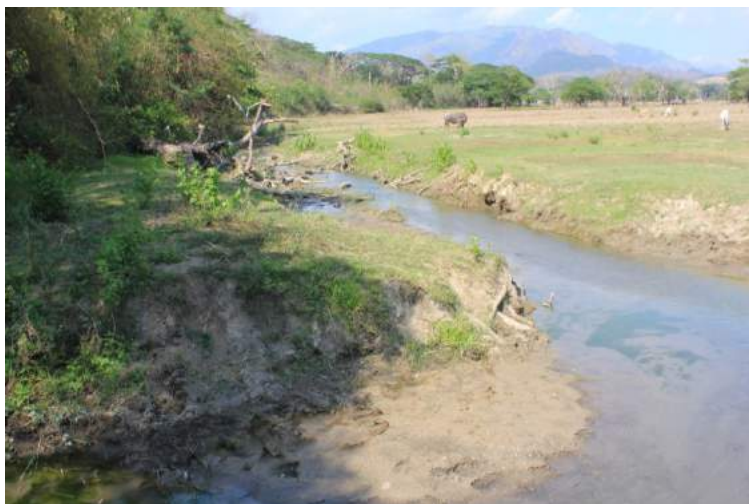
Figure 1A-112. Water diverted from Anahawin River to the intake

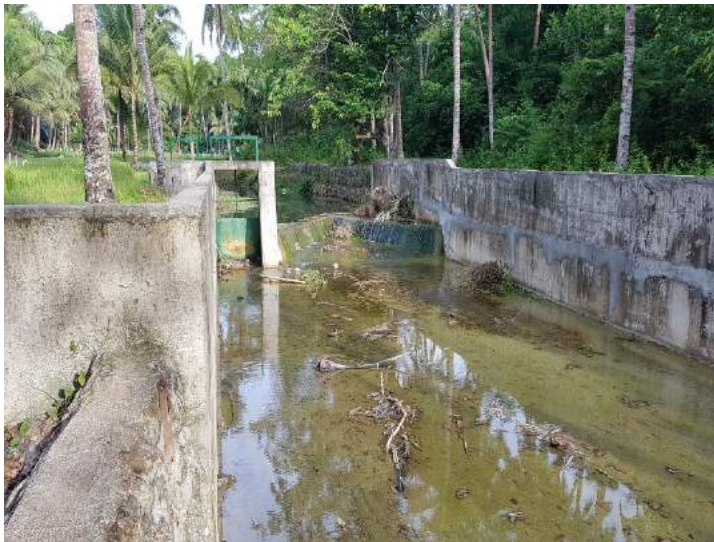
The current dam was constructed in 2012 (Figure 1B- 9) upstream of the original dam and the new main canal was constructed along the original main canal, using the old concreted side walls as support. The dam has a duckbill-type weir to increase crest length and reduce backwater flow effect with increase in flow. This is necessary to prevent flooding in nearby farms during high water flows which frequently occur in the area.

Figure 1B- 9. The new dam of the Maljo CIS constructed in 2012. It is a run-of-the-river type dam with a duckbill crest

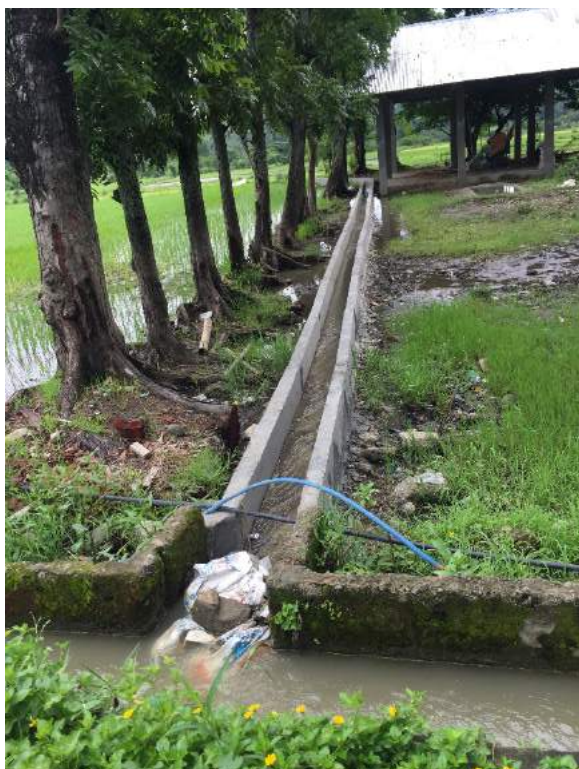
Figure 1B- 26. The newly built lateral canal of the system

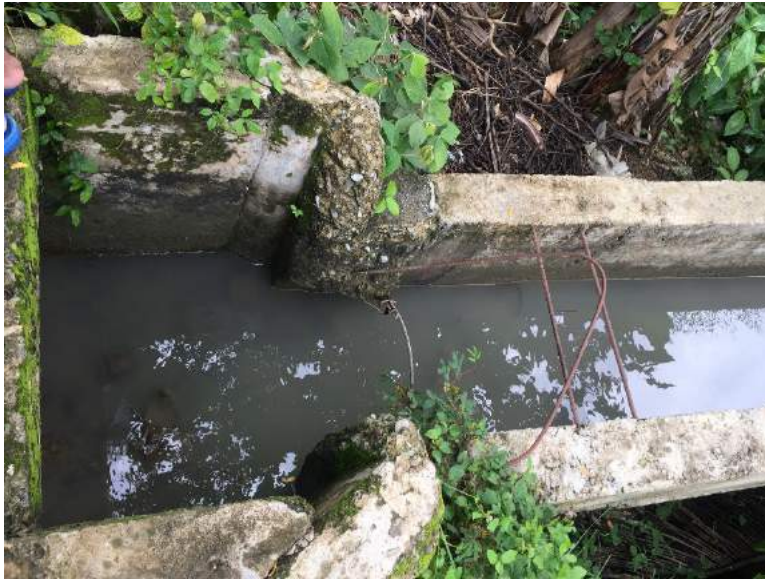
Figure 1B- 28. Connection of the main canal and the elevated flume showing the difference in width and height

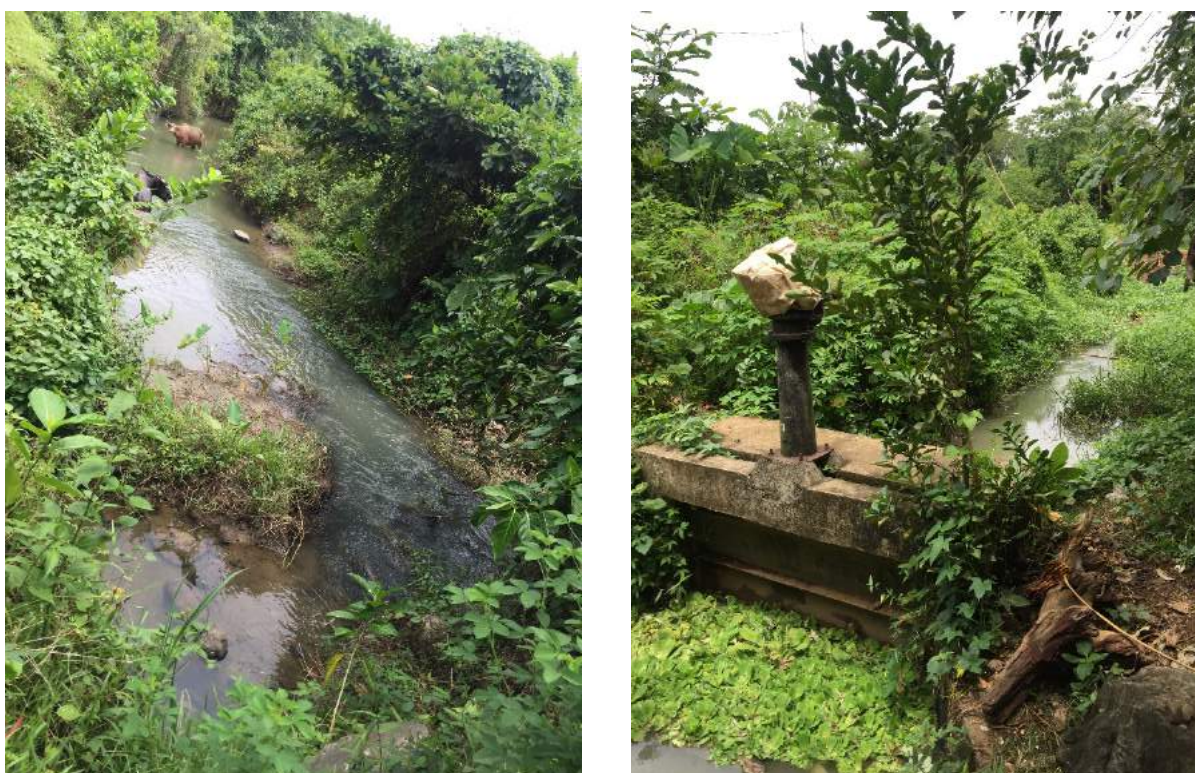
The CIP has a 12-km main canal and all but a few stretches are not lined yet, although there are several concrete control gates within the system (Figure 1B- 30). The design service area was 780 ha and the IA is working out for the right of way on Poblacion Ilaya to allow the construction of line canal to traverse it to Poblacion Ilawod and Fernandez. There are also some parts where the main and lateral canals are not connected yet. The system still has sufficient water even during summer. Since the main and lateral canals are unlined, they are easily damaged by strong flows. There are also two sluice gates on the dam but only one machine is fully functioning to operate them. The dam is not silted, and dredging is not needed.

Figure 1B- 30. The unlined main (left) and lateral (right) canal with some control structure

The association will request to NIA the concreting of the main and lateral canals. Officials of the association admitted lack of support from the local government unit.

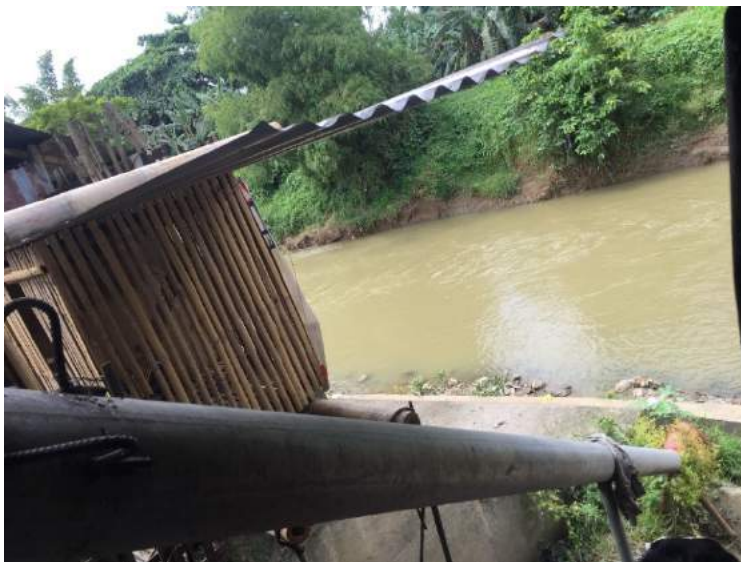
Figure 1B- 34. The 6" suction pipe used in drawing water from the Mambusao River

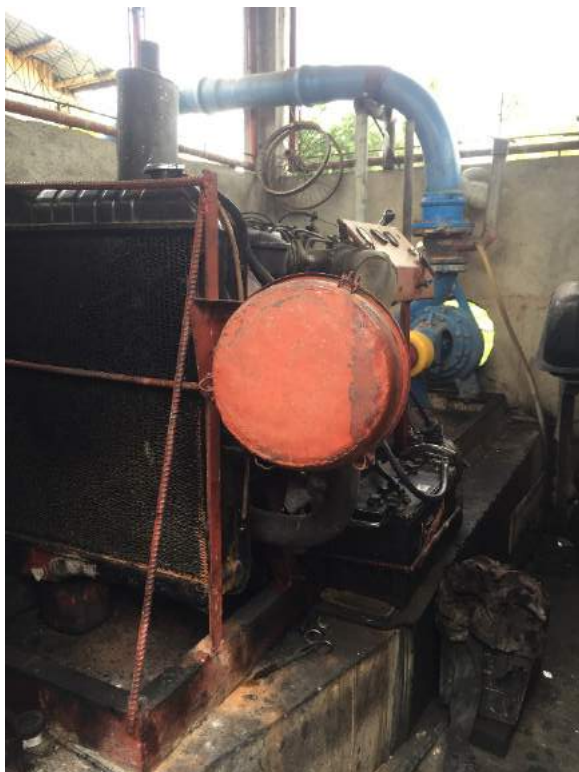
Figure 1B- 35. The centrifugal pump and the diesel engine of the Sigma Sur PCIS

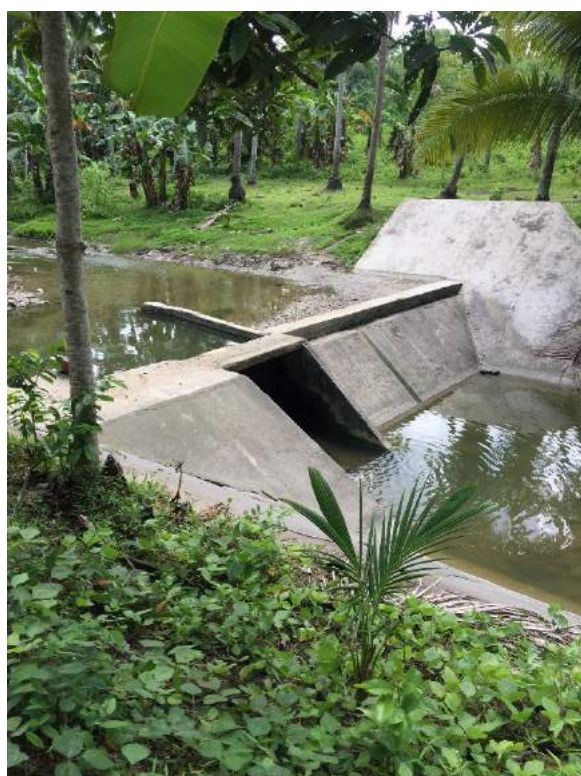
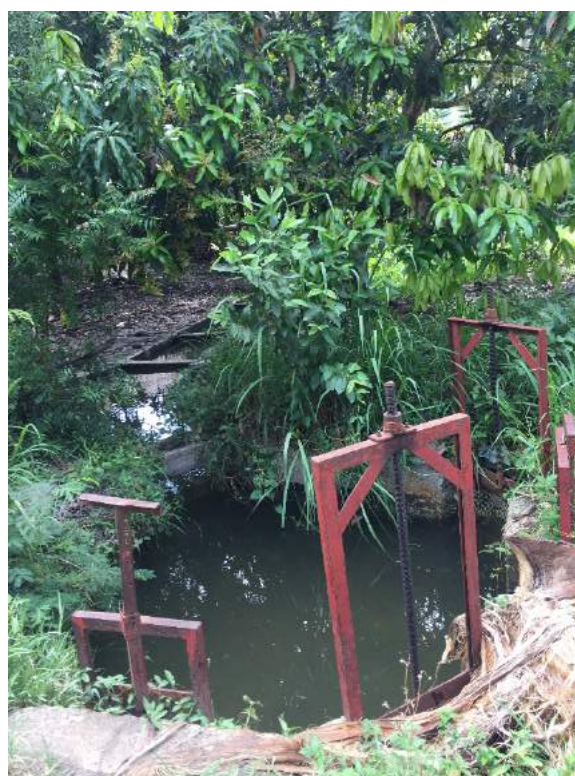
The dam (Figure 1C-5) was built in 1979 and started operation a year after. After completion of the project, however, problems emerged including no steels and unstable trapezoidal canals. Many parts of the main canal are still unlined and there is a broken section in the lined part (Figure 1C-6). The system was turned over to the IA in 1990. It is managed by Latale New Katipunan IA and at present have 81 rice farmer-beneficiaries.

Figure 1C-5. The dam of New Katipunan CIS with the head gates

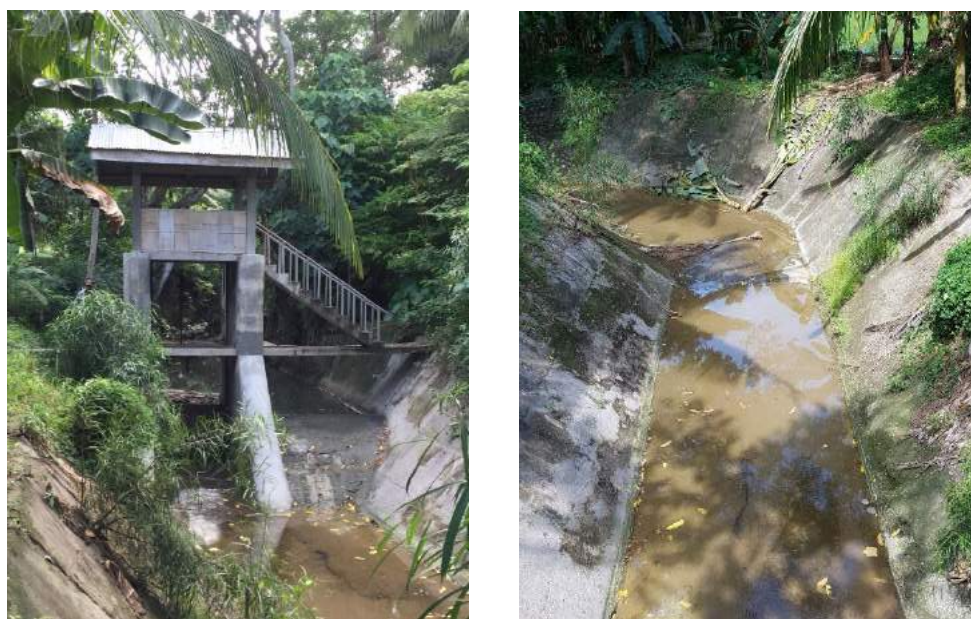
The old dam, built through FSDC in the 1980's, was an ogee-type dam with a wooden plank serving as the gate. After the rehabilitation in 2013, the buttress dam with a sluice gate was constructed (Figure 1C-8), the upstream and downstream apron and side walls were extended, the spillway and intake were repaired, additional concrete lining of 4 km of canal, and a rest area for the water master above the dam was added. The rehabilitation cost a little less than ₱8 M, and complete turn-over to the IA was done in 2015. The previous screw-type sluice gate was then replaced by the IA with a chain block for faster lifting costing them ₱4500. The main canal (Figure 1C-9) is lined but the lateral canals of the system are still earthen.

Figure 1C-8. The dam of Butilon CIS with the extended apron and side wall

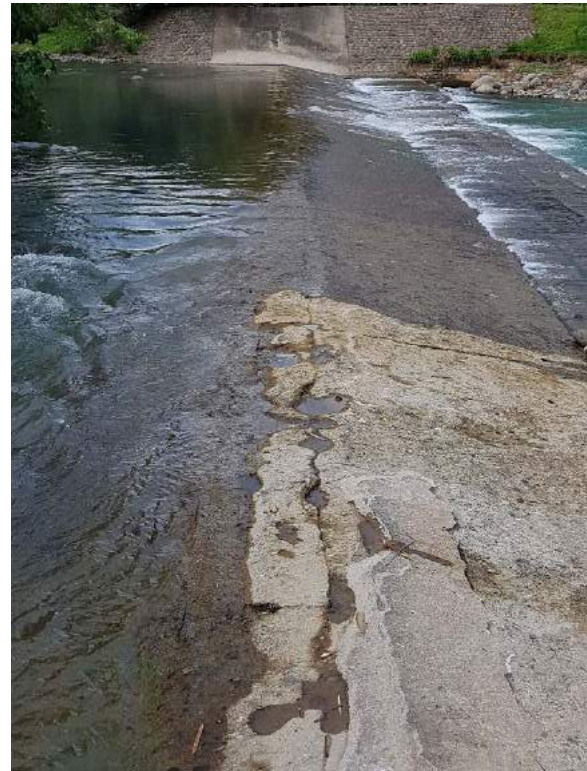
Figure 1C-10. The dam of Del Carmen CIS

The current dam (Figure 1C-10), including the steel sluice gates and intake gates (Figure 1C-), were constructed by NIA in the 1990's. There were problems of sediments and debris flow so the IA added a silt control structure (Figure 1C-11) costing the IA about ₱50,000. The same problem caused damaged to the sluice gate and the IA repaired it at a cost of a little less than ₱30,000. The dam structure and lining require some repair due to debris and boulder laden flow and the IA conduct regular dam cleaning and desilting. The single gated sluice gate was deemed insufficient and the direction of the training wall is causing more sediments to flow to the intake gates than be flushed through the sluice gates. Most of the main canal is lined although some parts, particularly near the dam, are submerged while some are damaged causing leakages (Figure 1C-12). Sands that accumulate in the main canals are collected and sold by farmers.

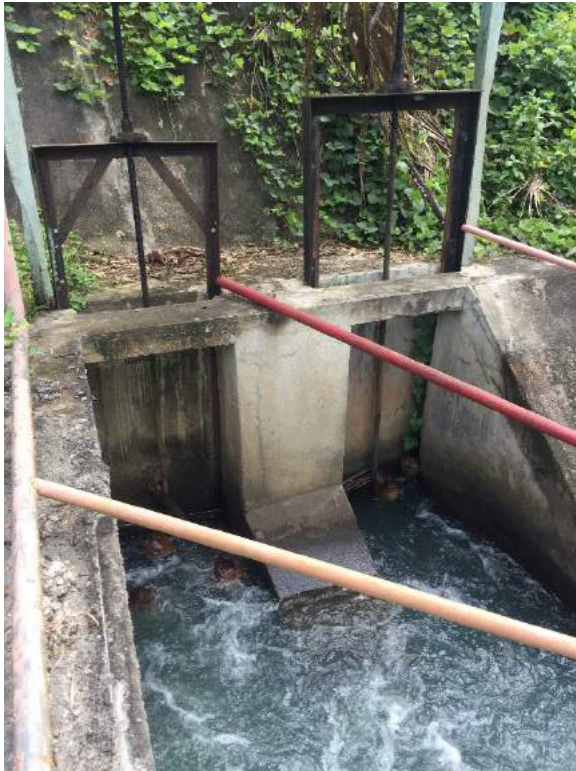
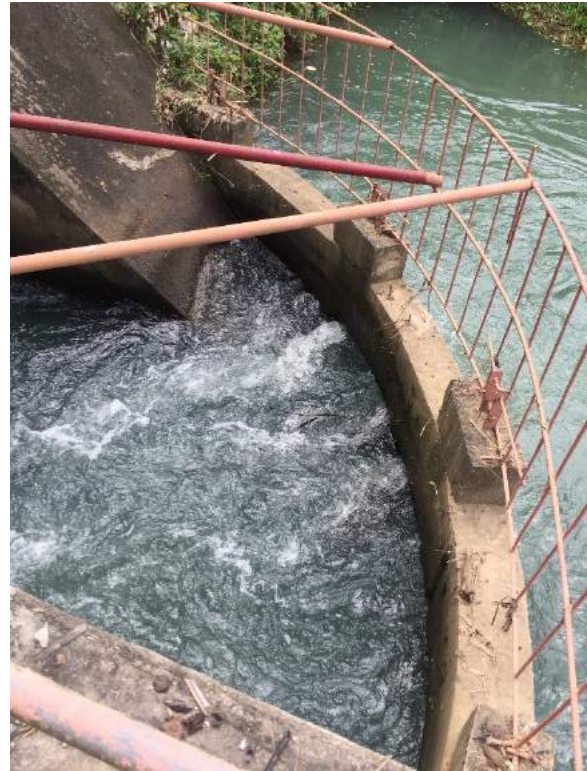
Figure 1C-11. The intake gates with the silt control structure funded by the IA

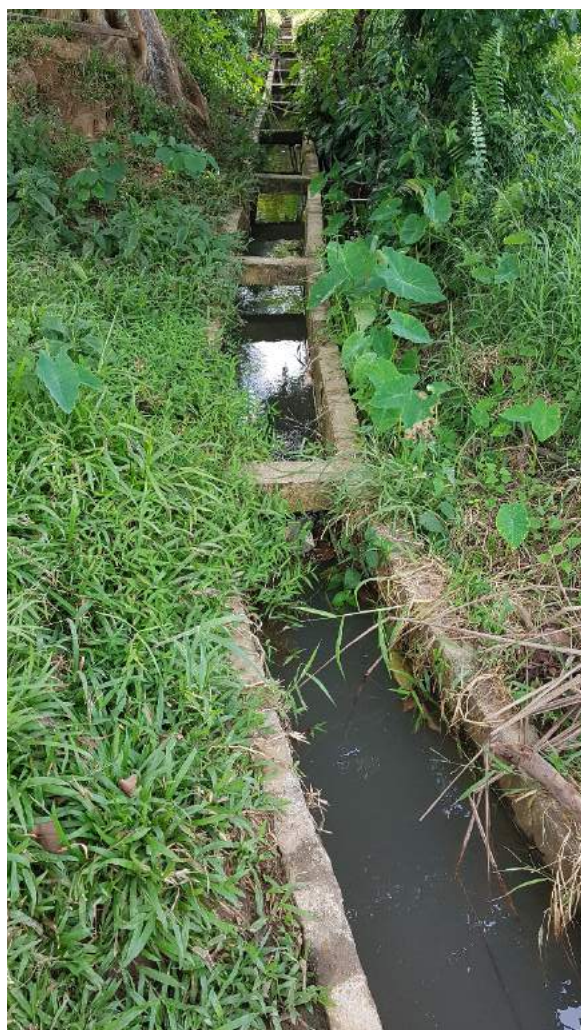
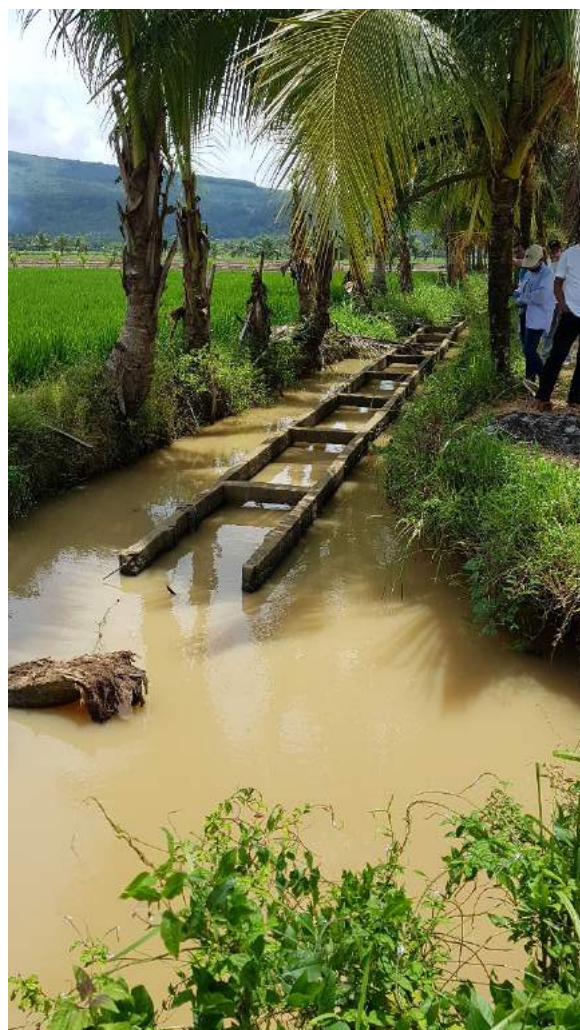
Figure 1C-14. The main canal near the dam and at the end of concrete lining

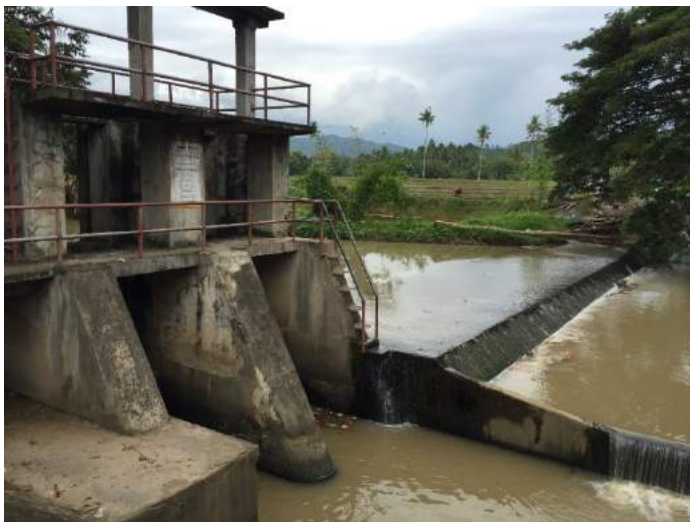
Figure 1C-18. The dam of Hervilla CIS

While the dam (Figure 1C-18) is still in good condition and the control gates are still working properly, the river is sediment laden and usually carry floating debris and rubbish (Figure 1C-19). The IA regularly conducts cleaning operation. The IA was granted a loan amounting to ₱13,622,922.22 in 1983, the equity being the labor of the farmers. Source of funds for equity payment mainly comes from IA-owned funds. The Hervilla CIS is already fully paid with their share in the construction of the IS. When asked regarding the FISA, the members interviewed said that there might be possible dissolution of IAs if collection rate of O&M fees will continue to decrease.

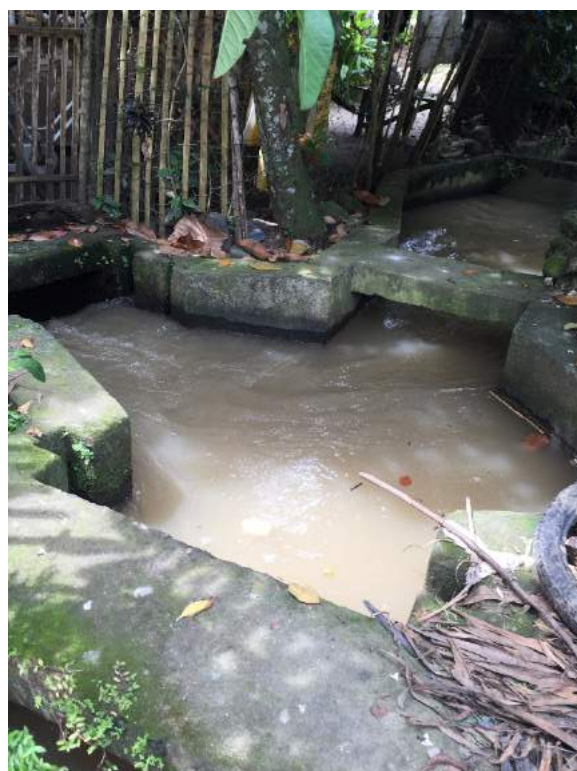
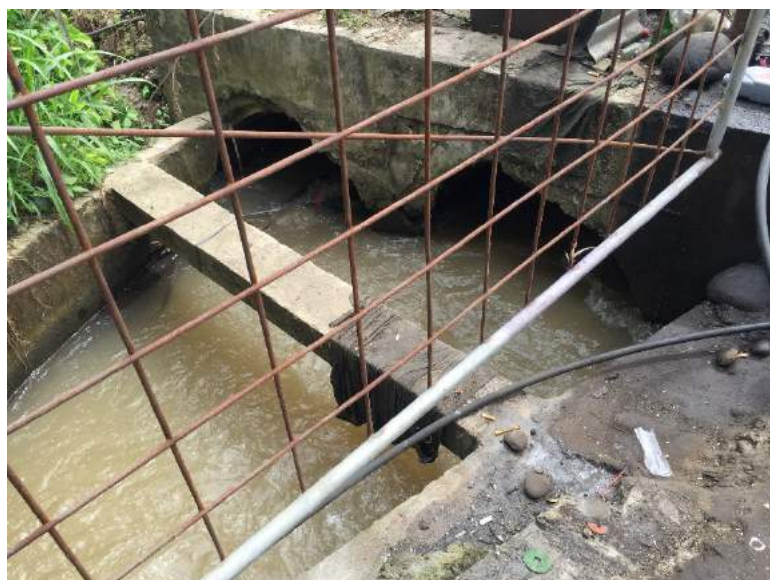
Figure 1C-21. Main canal of the system after the culvert road crossing

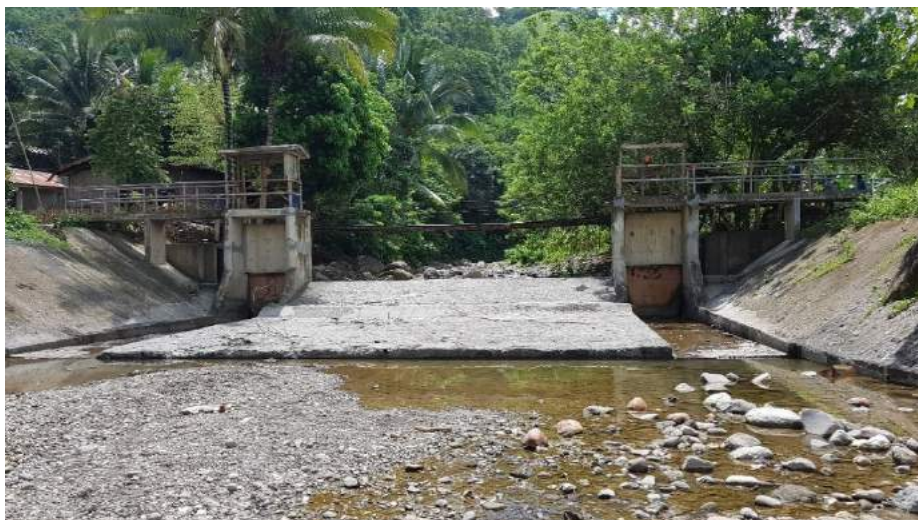
The original dam was built in 1975 through the FSDC and the previous gates were made of wood. The dam was 4-ft deep before but was filled with rocks and boulders starting 2003. It was replaced by NIA in 2013 with a new dam (Figure 1C-32), including steel sluice gates and intake gates on both sides, and lined canals. Last 2017, the dam was damaged due to typhoon Vinta and the dam storage is again filled with rocks and boulders. The downstream apron of the dam is also damaged with scoured concrete lining and exposed steel frames (Figure 1C-33). The lifting mechanisms of the gates were replaced with secondhand chain blocks bought by the IA at ₱6,000 for the 5-ton capacity and ₱5,000 for the 3 tonners.

Figure 1C-32. The dam of Delapa CIS

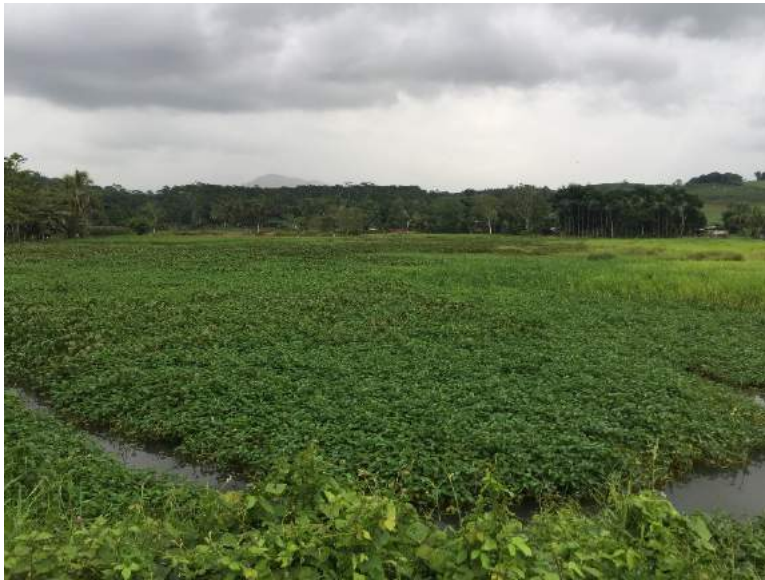
Figure 1C-36. The reservoir of Magsaysay CIS

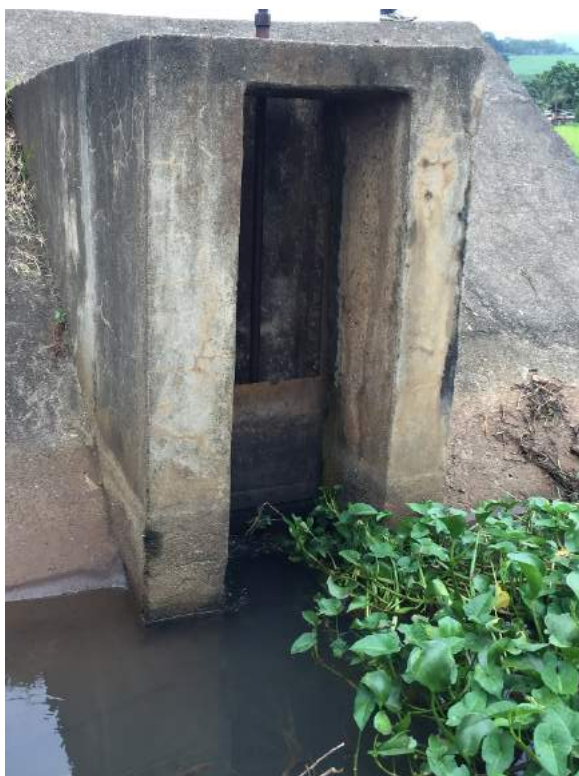
Figure 1C-38. Right main canal intake with 0.5 m width
